**SAFETY COMPLIANCE TESTING FOR FMVSS 201U**  
**Occupant Protection In Interior Impact**  
**Upper Interior Head Impact Protection**

**GENERAL MOTORS CORPORATION**  
**2004 Chevrolet Colorado LS**  
**NHTSA No. C40112**

**FINAL REPORT**

| 4. Title and Subtitle<br>Final Report of FMVSS 201U Compliance Testing of a<br>2004 Chevrolet Colorado LS, NHTSA No.C40112 | | 5. Report Date<br>April 16, 2004 | |

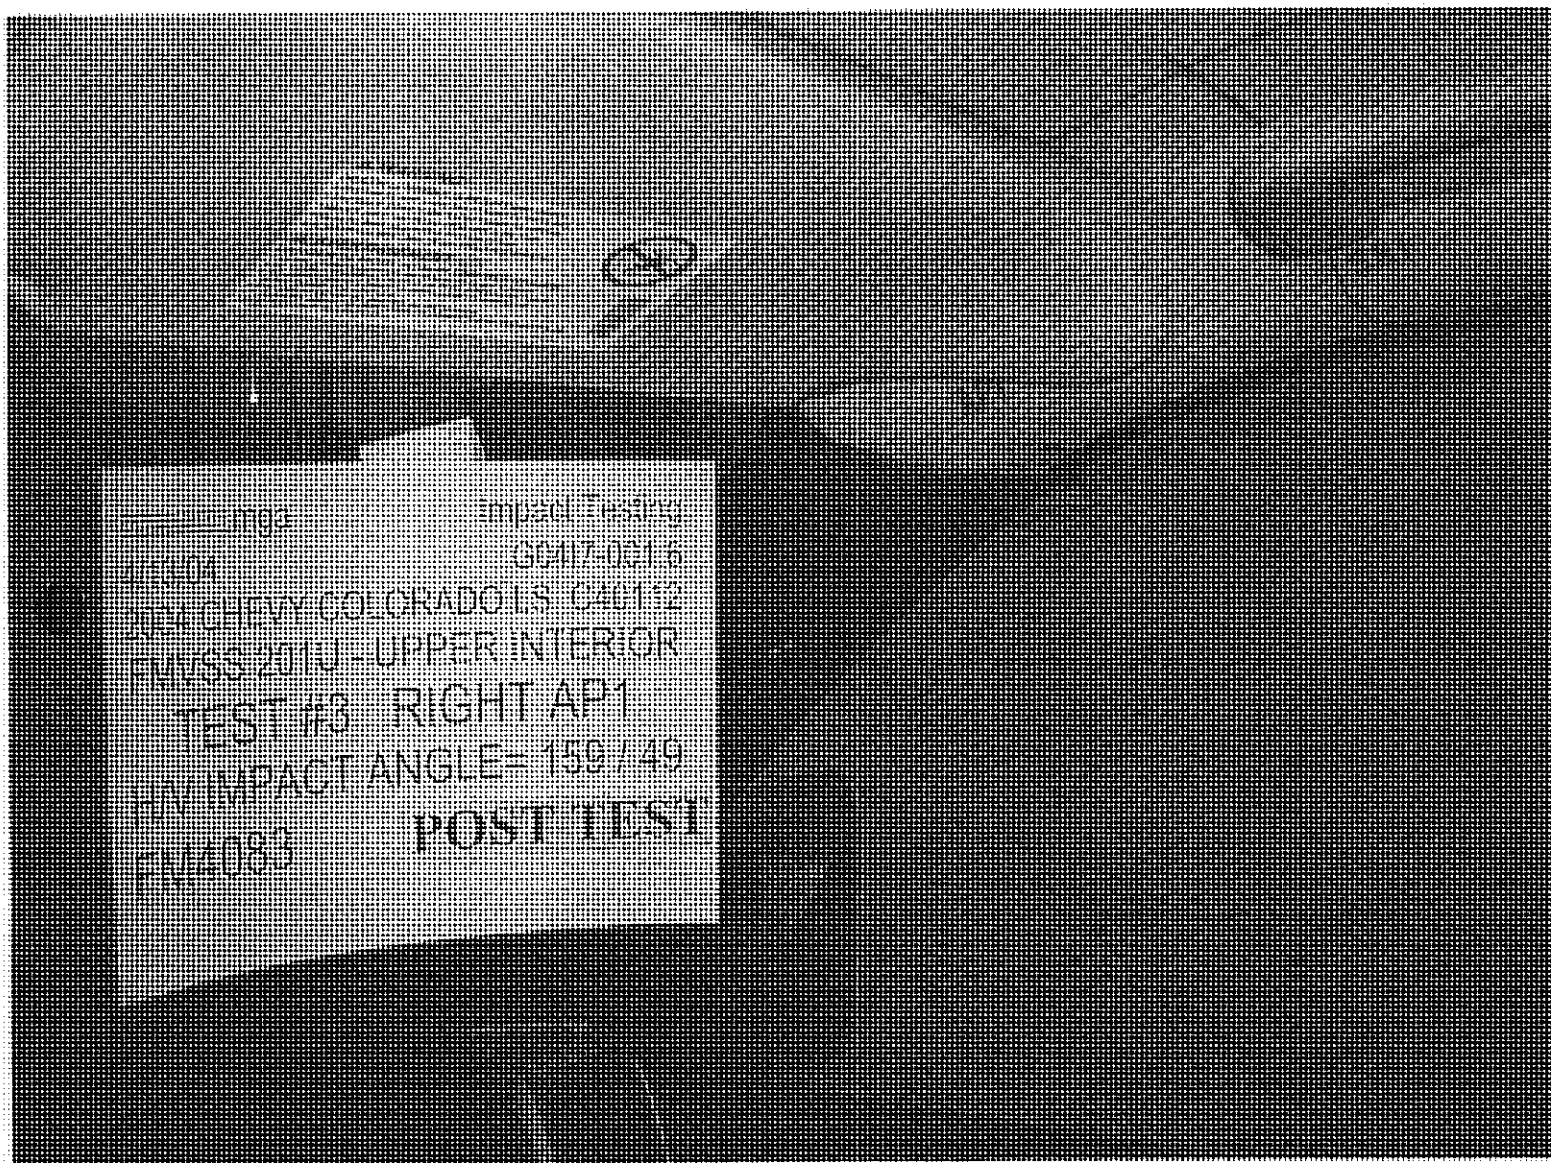
Impact Testing  
4/13/04 G0417-001.6  
2004 CHEVY COLORADO LS G40112  
FMVSS 201U - UPPER INTERIOR  
TEST #3 RIGHT AP1  
HV IMPACT ANGLE= 159 / 49  
FM4083 POST TEST

NO VISIBLE DAMAGE
